AUGUST 1968 THE NAVAL AVIATION SAFETY REVIEW

# HARD LANDINGS

**A review  
of FY 69  
major hard landing  
accidents indicates  
that lack of  
effective supervision  
was a major  
factor.**

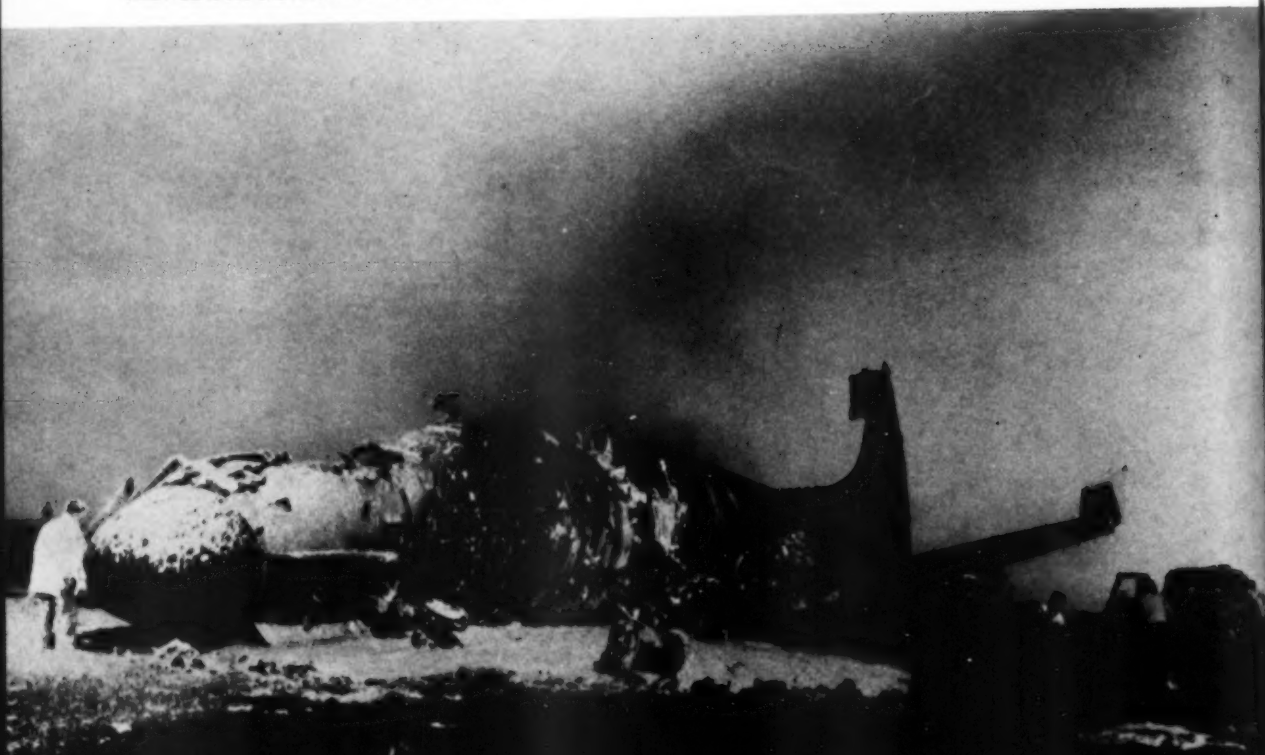
This P-3B is the end result of one hard landing.

The precise cause of this accident could not be determined. Extensive investigation by the board failed to reveal any material failure or emergency situation, either real or imagined, which occurred prior to the accident which could have contributed to it.

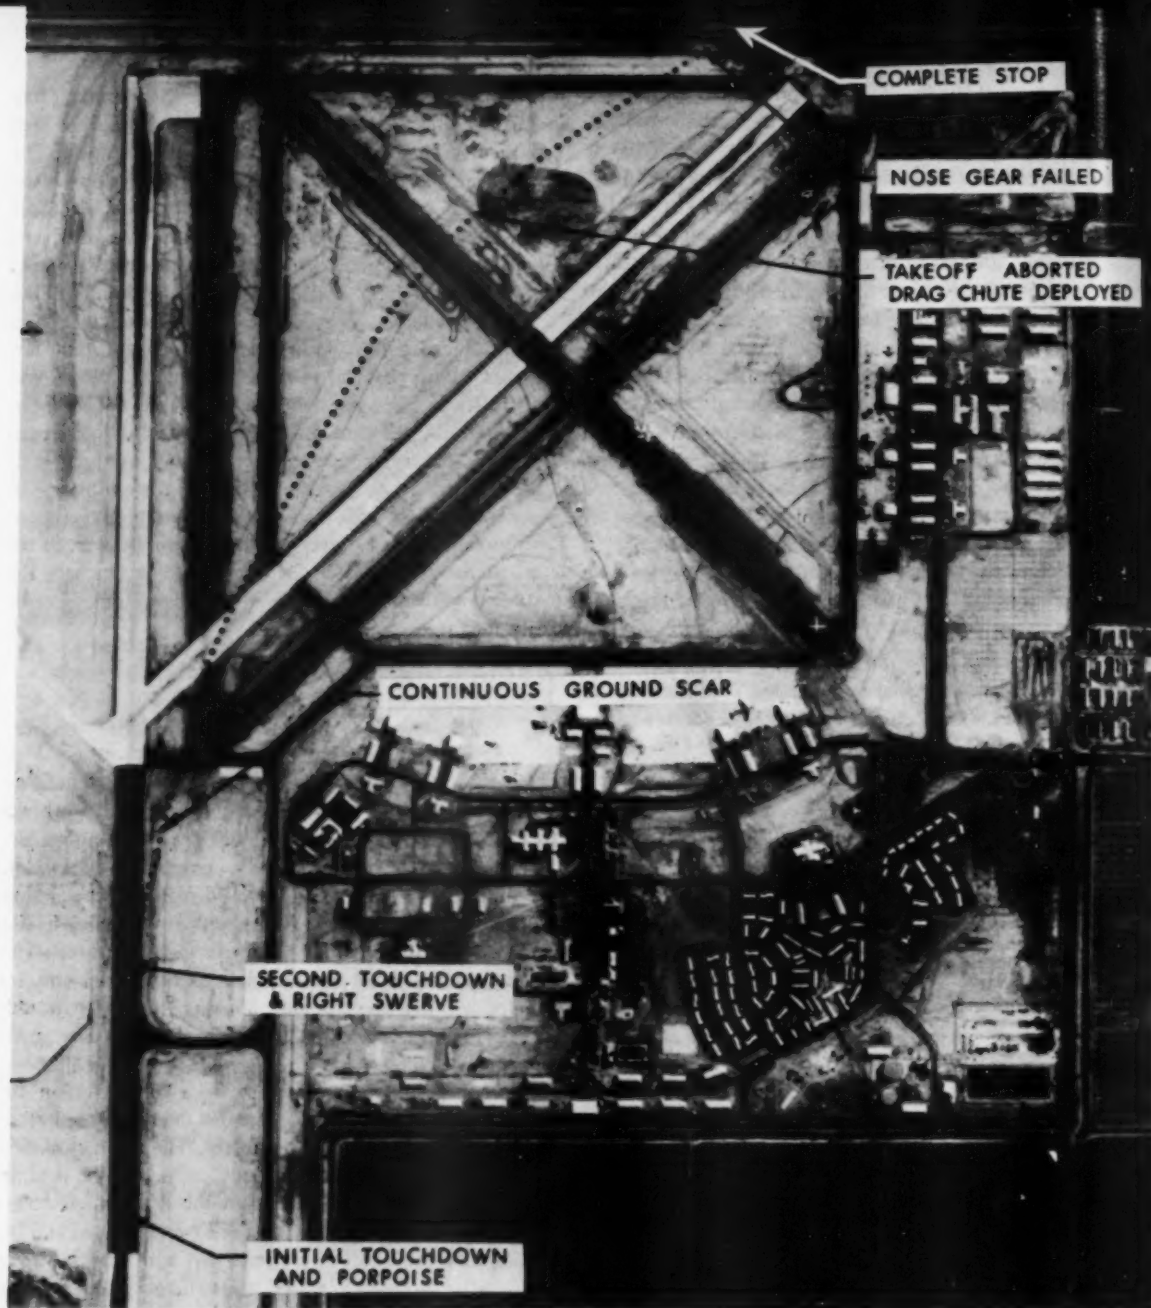
The path of the A-3B after the landing porpoise.

chute deployed. The nose gear collapsed when the aircraft crossed a ditch parallel to the perimeter road. The aircraft crossed the road and came to rest 10 ft short of the boundary fence. The instructor secured both engine master switches. Without injury, all three personnel exited the aircraft via the upper hatch. The aircraft received substantial damage.

It was concluded that the primary cause of this accident was error in judgment and technique by both the pilot and the instructor. A higher than normal sink rate caused the aircraft to bounce into the air on touchdown. This bounce plus an addition of power caused the nose to raise and a classic porpoise maneuver began. The instructor correctly called for full power and

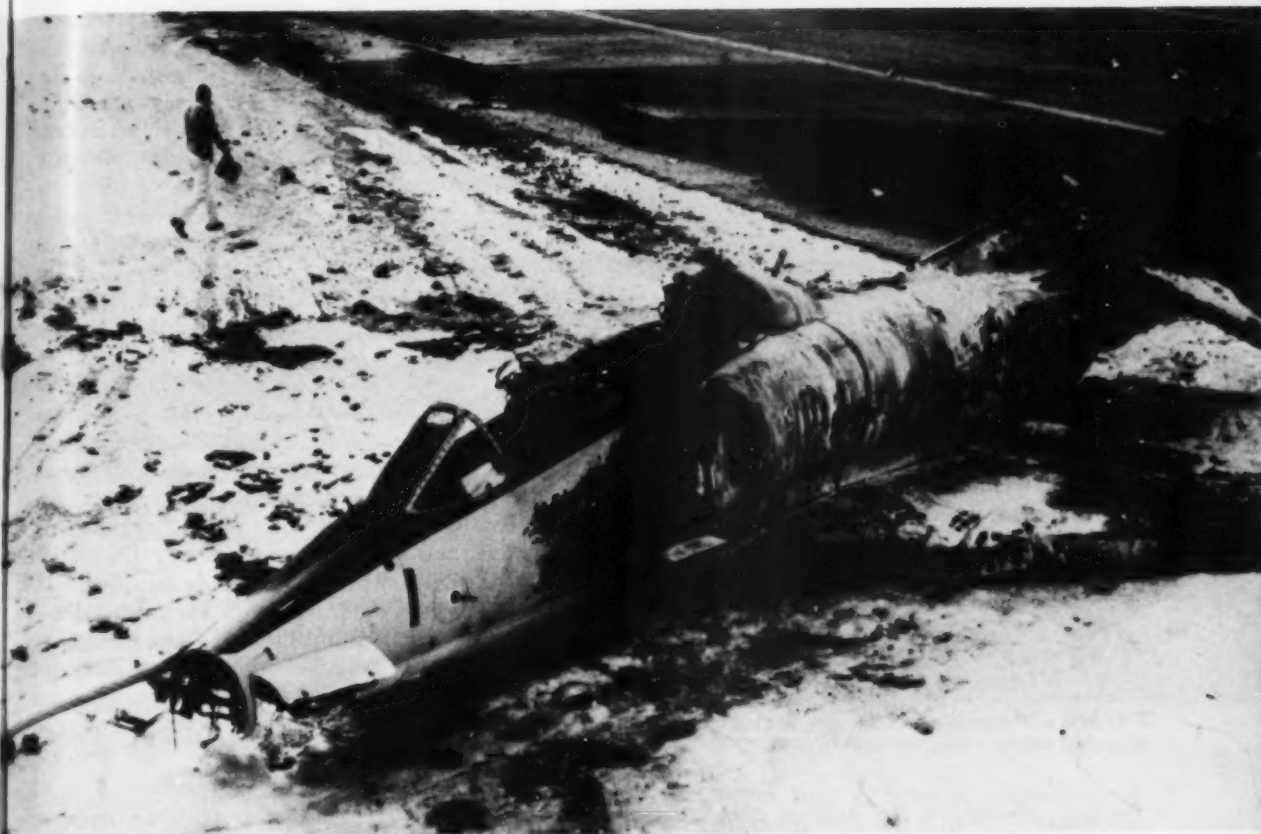
The aftermath of an over-weight, wrapped-up approach.

The reason for this hard landing and subsequent loss of the aircraft is fairly obvious — a high sink rate caused by high gross weight, too little power and a wrapped up approach. As soon as the excessive sink rate was noticed, the prudent thing to do would have been to add full power, level the wings and discontinue the approach. This, the pilot failed to do.

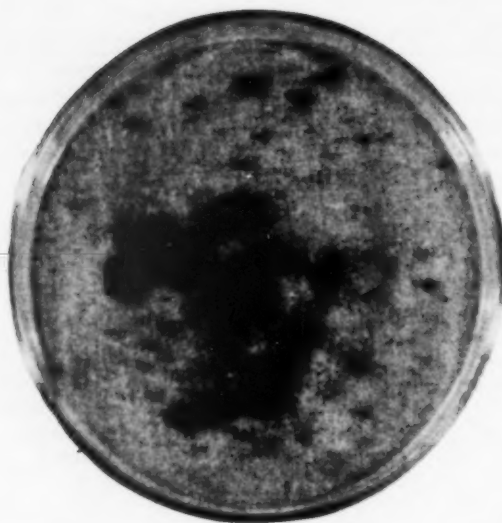
Decomposed insect matter found in aircraft pitot-static system (displayed in 3-inch diameter dish).

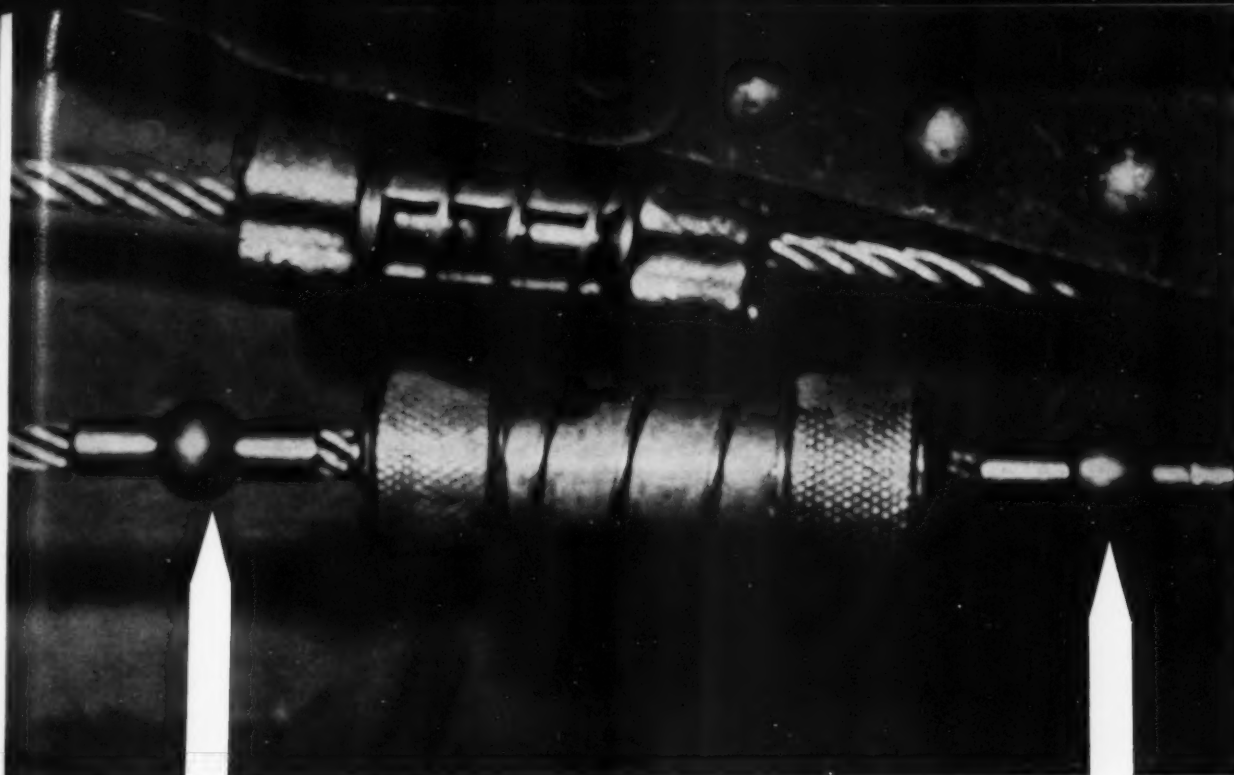
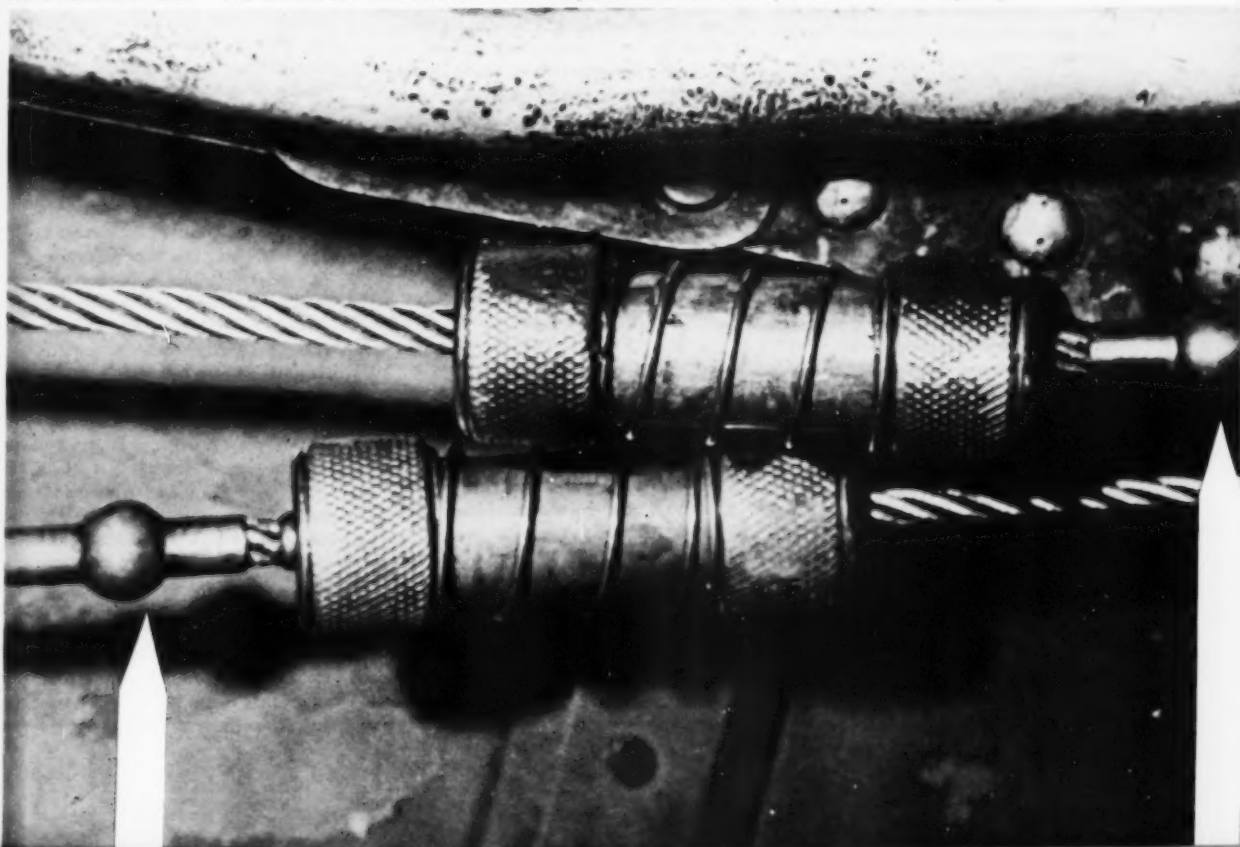
TAF-9J Starboard Side The 'Double-Ball' connectors of elevator 'Down' cable are properly attached to same quick-disconnect fitting. ▲

TAF-9J Starboard Side The 'Double-Ball' connectors are incorrectly attached to different quick-disconnect fittings. ▼
